REVIEW OF SOILS DESIGN, CONSTRUCTION AND
PERFORMANCE OBSERVATIONS JOHN H. KERR
PROJECT (BUGGS ISLAND AND ISLAND CREEK
DAMS).

**REVIEW OF SOILS DESIGN, CONSTRUCTION
AND PERFORMANCE OBSERVATIONS
JOHN H. KERR PROJECT
(BUGGS ISLAND AND ISLAND CREEK DAMS)
VIRGINIA**

TECHNICAL REPORT NO. 3-464

**U. S. Army Engineer Waterways Experiment Station
CORPS OF ENGINEERS**

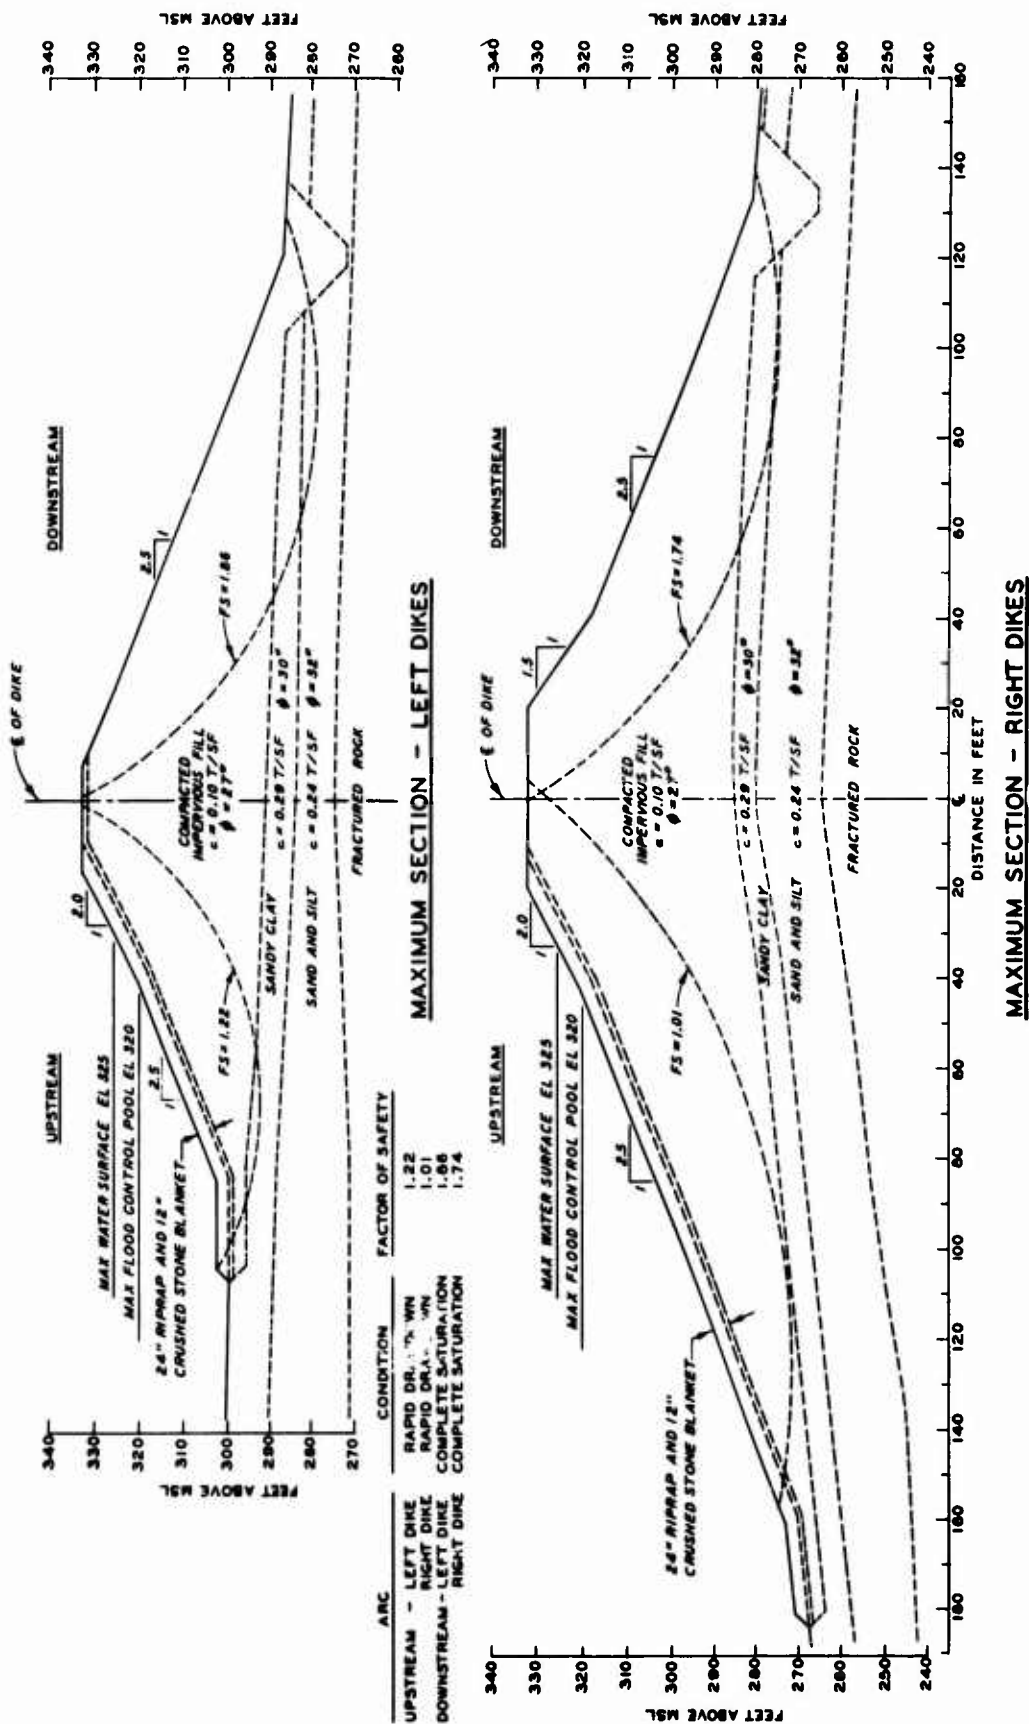
Fig. 14. Stability analyses for embankments and foundations, Buggs Island Dam

25. Stability, settlement, and seepage analyses. Stability analyses for embankments and foundations of the dikes were made using the circular arc method and shear strengths determined by the consolidated-drained direct shear test. Analyses were made for maximum dike sections on both left and right banks of the river. Stability arcs for these sections are shown in fig. 14. Upstream slopes were analyzed for a condition of rapid drawdown from a flood control pool at el 320. Downstream slopes were analyzed for the condition of complete saturation. Computed minimum factors of safety are shown in fig. 14. A minimum factor of safety of

1.01 was obtained for the upstream slope of the right dike for the rapid drawdown condition. Because the assumption of rapid drawdown is conservative, and since the maximum section applies only to a limited length of dike (approximately 45 ft on the right bank), the factor of safety of 1.01 for this condition was considered satisfactory.

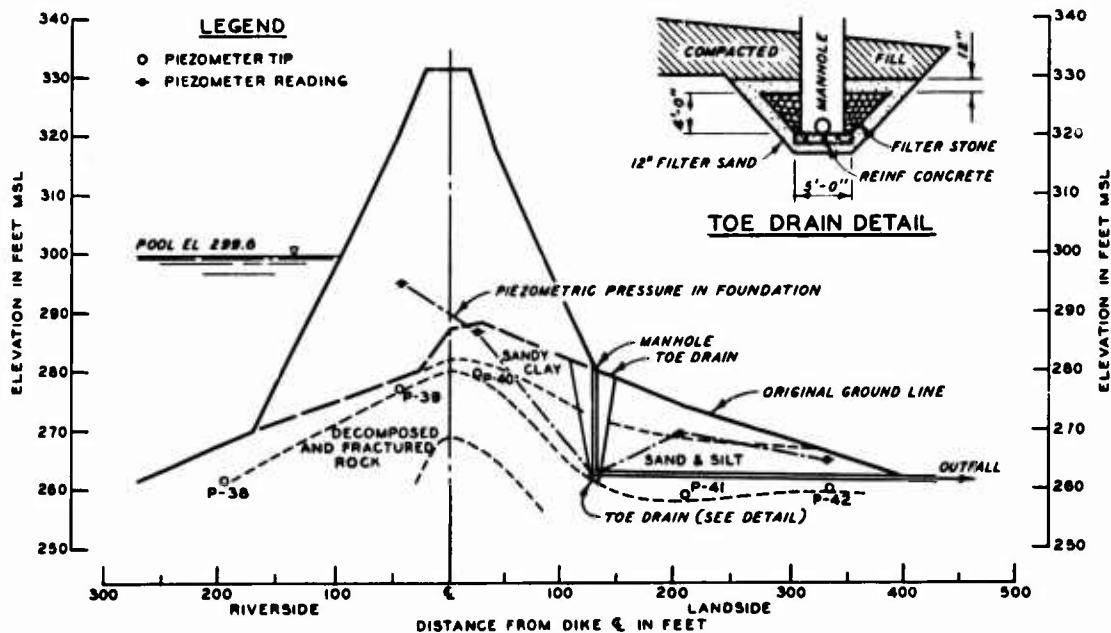
Fig. 18. Piezometer readings at sta 261+18 for pool elevation of 299.6 ft, Buggs Island Dam

48. The highest reservoir stage to date, el 305, occurred in August 1955. Readings from piezometers installed in the foundation have been taken at various times and now are being read monthly. The piezometer tips are located immediately above the decomposed rock stratum and

consist of 1-1/2-in.-diam by 18-in.-long, brass-jacket wellpoints placed in 6-in.-diam by 2-ft-6-in.-long pockets of clean coarse sand. Piezometers at sta 261+18 are shown in cross section in fig. 18, and a plot of piezometric pressure observed in July 1953 for a pool elevation of 299.6 is also shown. No apparent excess pressures are present in the dike foundation at this maximum section. Variations in reservoir level and piezometer readings vs time at sta 261+18 are shown in fig. 19. The data show

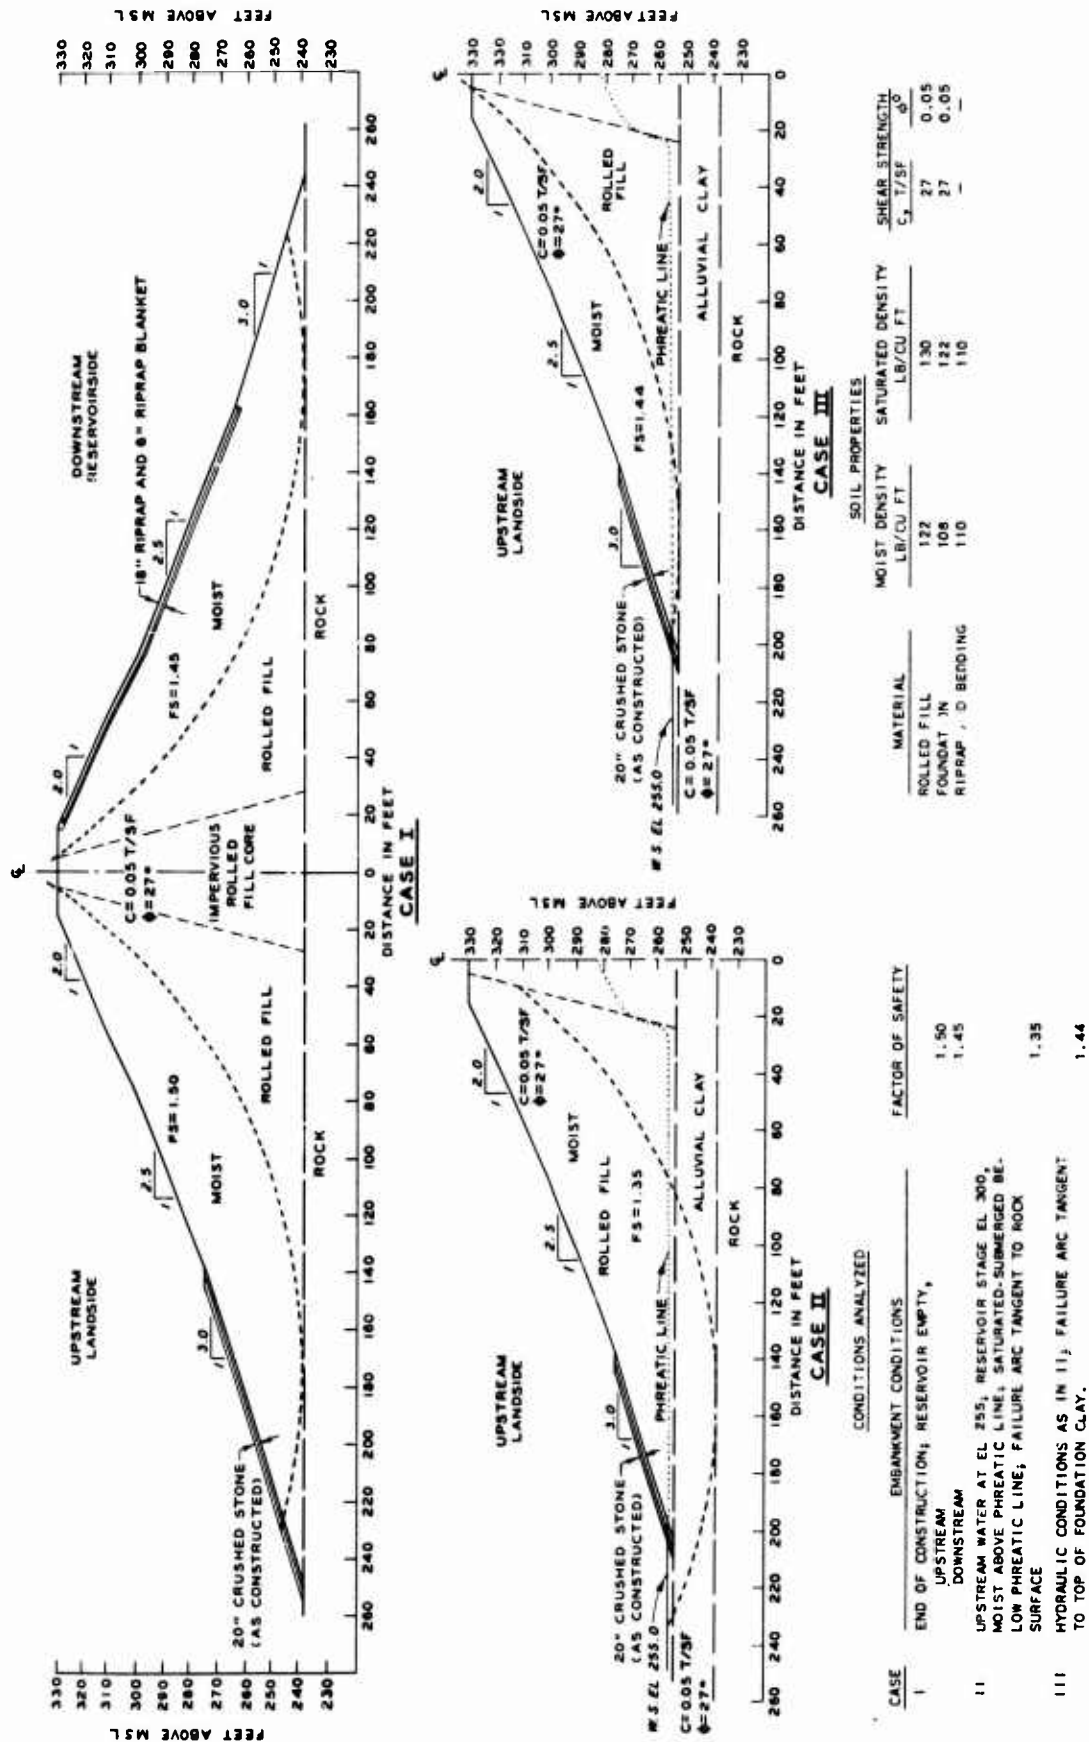
Fig. 27. Stability analysis for embankment, Island Creek Dam

66. Stability, settlement, and seepage analyses. The circular arc method was used in making stability analyses of the embankment. Conditions analyzed and soil properties used in the analyses as well as the results are shown in fig. 27. Analyses were made for the maximum embankment
